# Reactivation of a geogrid-bridged sinkhole: A real life solution approval

Dimiter Alexiew, HUESKER, Germany

## Reactivation of the sinkhole on the 17<sup>th</sup> Oct. 2001 about 18:00 h

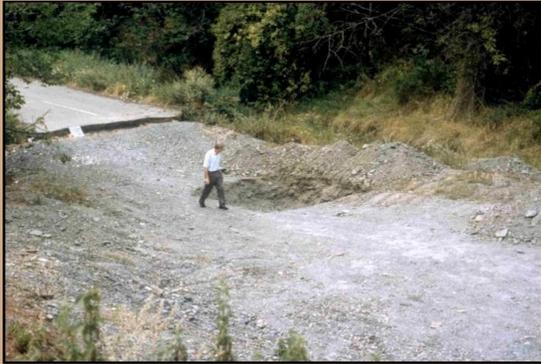
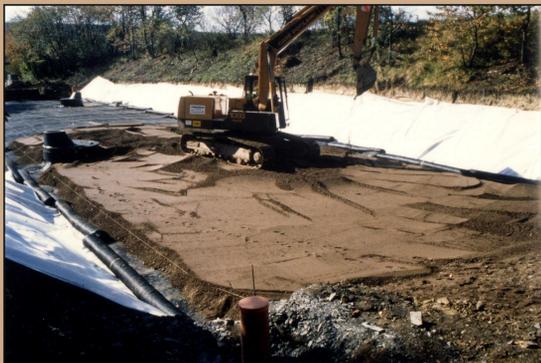
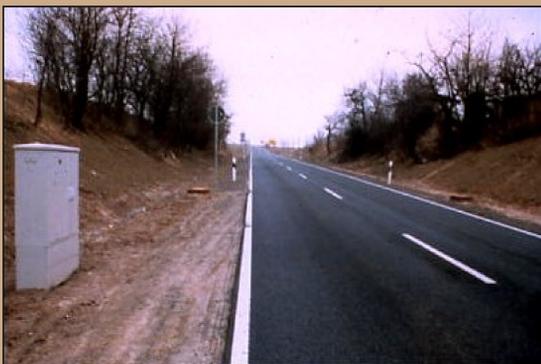
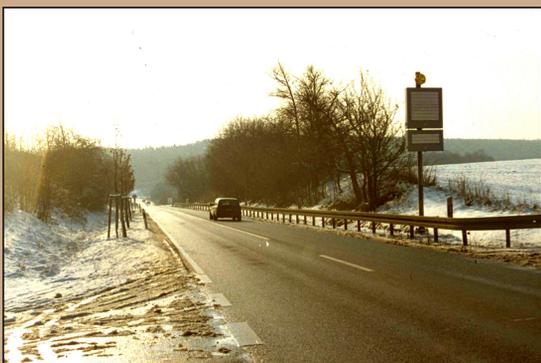
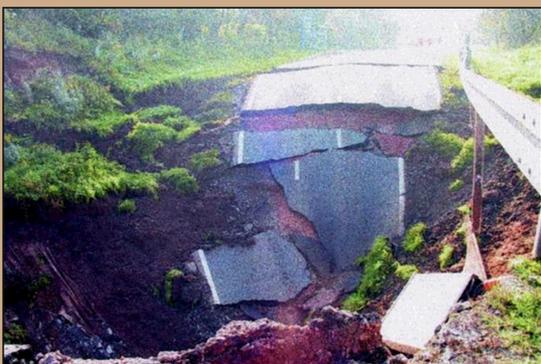
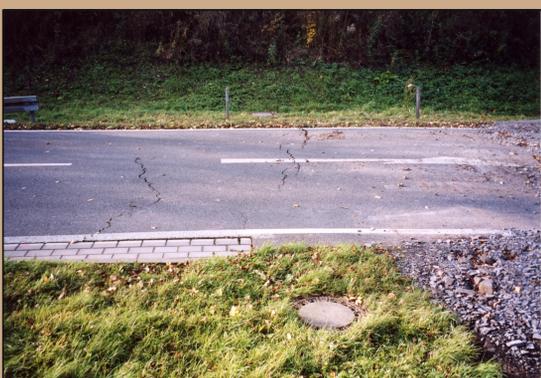
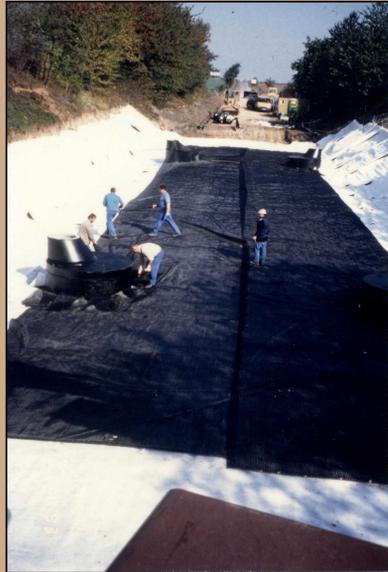
- 18:00** Noises were registered in the neighbourhood. Cut slopes on both sides start to slide. First contour of the sinkhole can be identified on the road surface.

- 18:30** Clear deflection of the road surface. Torsion starts step by step. Traffic continues at up to 100 km/h; automatic warning signs are still not activated

- 18:45** Deflection increases. Still no activation of the warning signs. Eyewitnesses from the neighbourhood try to stop the traffic without any success. Traffic continues.

- 19:00** People from the neighbourhood and meantime the police eventually stop the traffic. Sinkhole funnel on a large area beneath the road. Deflection increases, longitudinal and cross inclinations also increase. A part of a slope on one side slides finally beside the road and disappears in the funnel. Warning system is still not activated.

- 19:30** Deflection and inclinations continue to increase; about that time the system collapses. The geogrids (they are not pulled out!) fail. They fail more or less at the mid-span of the funnel.
